Building Inspection Report

123 Any Street, Anytown, Illinois

Inspection Date:
February 16, 1997

Report Number:
17310

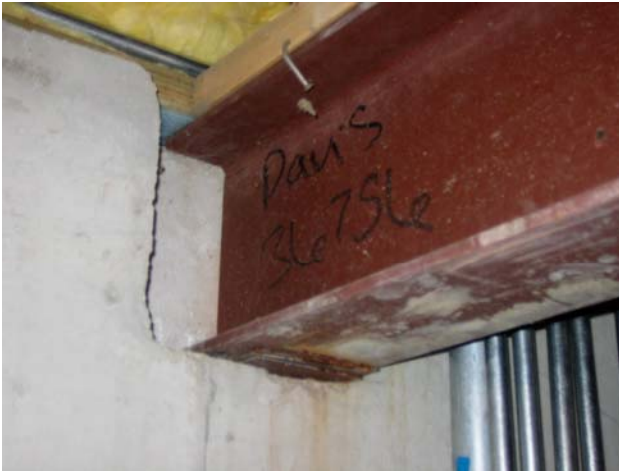
- **Repair:** The ends of the main support beam should be cemented into the "beam pockets" to reduce the risk of structural movement and damage.

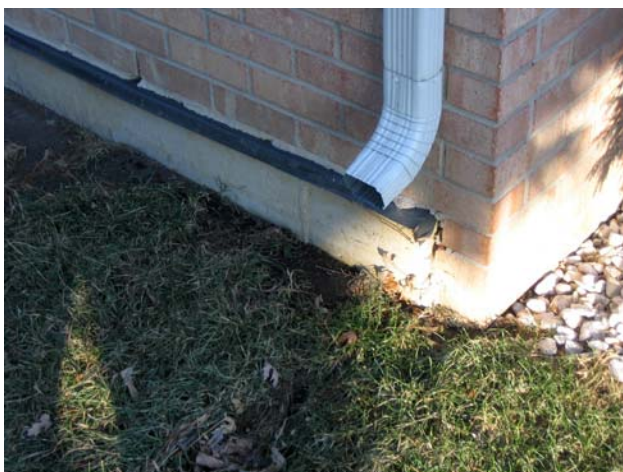
- **Repair:** The downspouts on the entire house should discharge water at least five (5) feet from the house. Storm water should be encouraged to flow away from the building at the point of discharge.

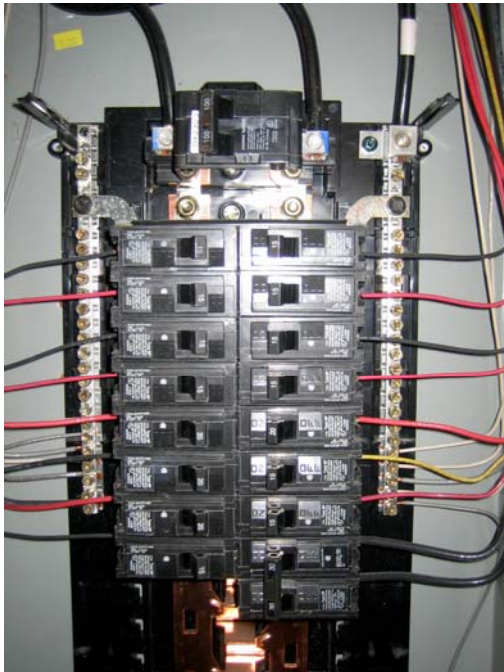
The electrical panel is well arranged and all breakers are labeled and properly sized.

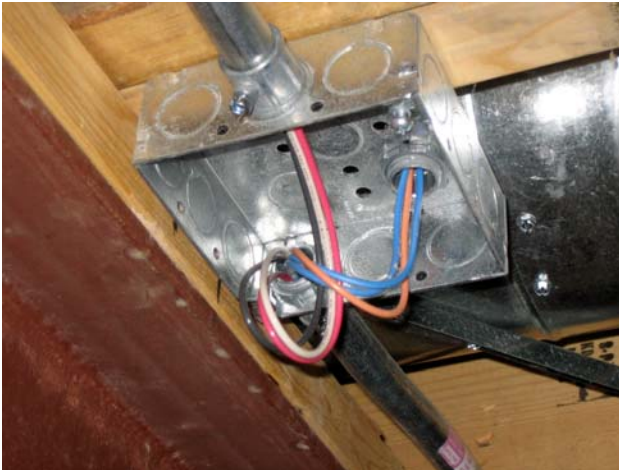
- **Repair:** The open junction box should be fitted with a cover plate, in order to protect the wire connections. This is an inexpensive repair.

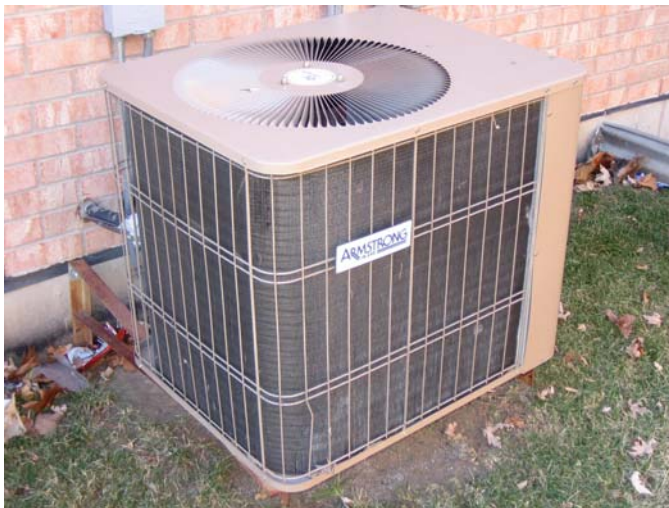
At 3 years old, the outdoor air conditioning unit is a relatively new unit that should have years of useful life remaining. Regular maintenance will, of course, be necessary.

The outdoor air conditioning unit is mounted to the house on brackets. This keeps the unit level, which is important for efficient system operation.

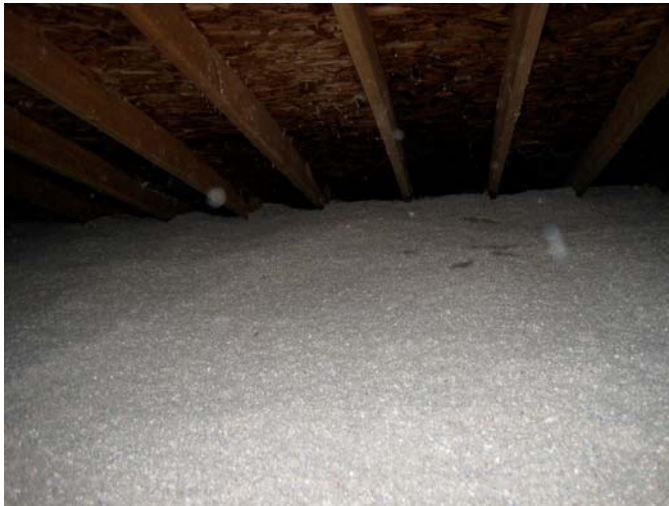
Insulation levels are considered to be typical for a home of this age and construction.

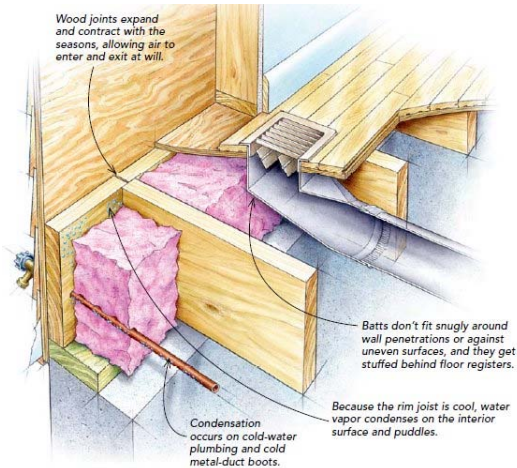
- Please note that these are not essential repairs, but are suggestions for long-term improvement:
It would be wise to insulate the "rim joist" cavities in the "unfinished" sub-basement.

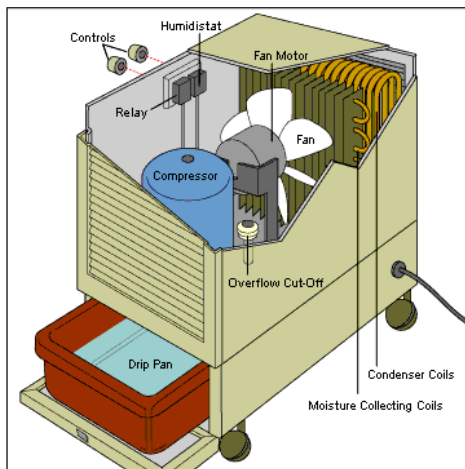
Placing a de-humidifier in the sub-basement would be a wise investment to reduce the dampness that is inherent in all basements.
