Building Inspection Report

123 Any Street, Anytown, Illinois

February 16, 1997

17310

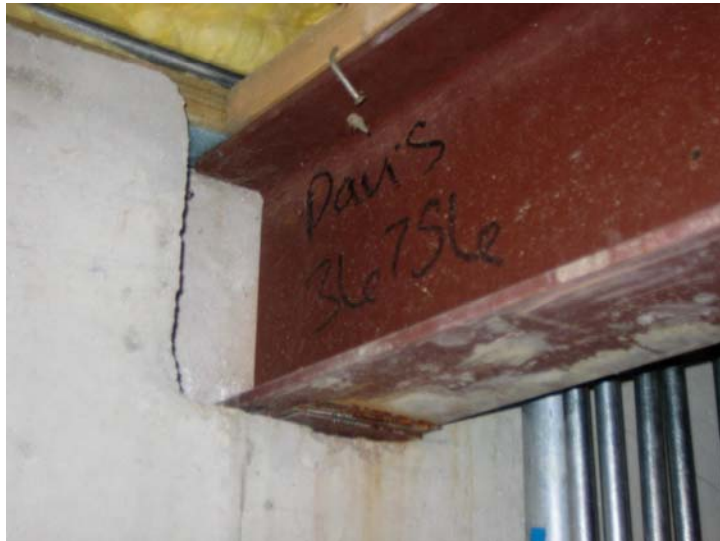
The end of the main support beam could be cemented into the "beam pocket" in the foundation to reduce the risk of structural movement and damage.

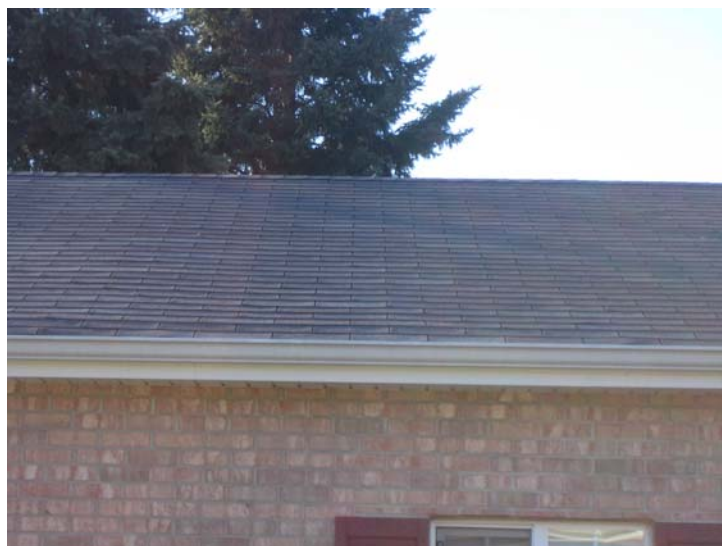
The roof coverings are considered to be in good condition.

A single layer of roofing materials exists.

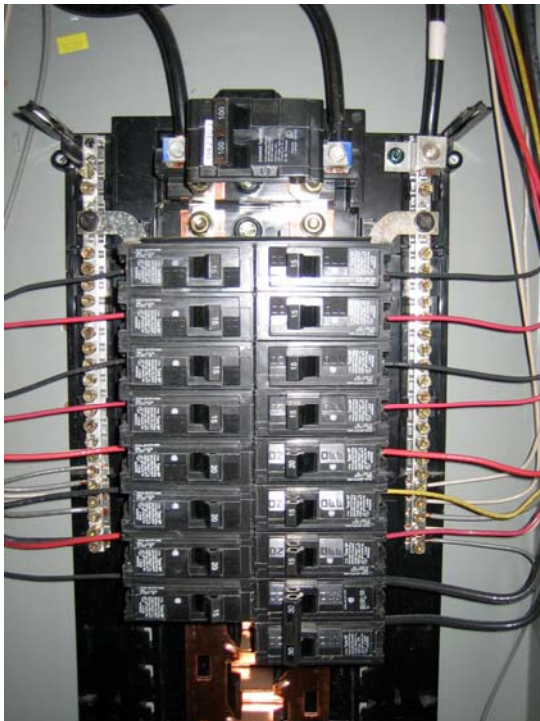
The electrical panel is well arranged and all breakers are labeled and properly sized.

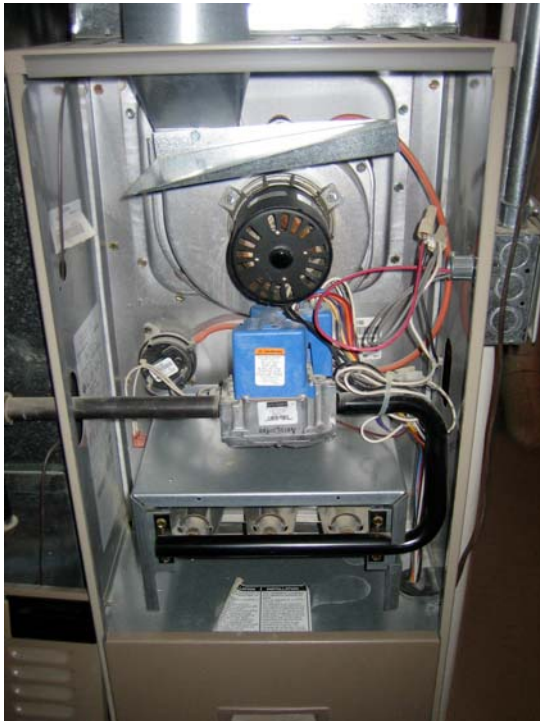
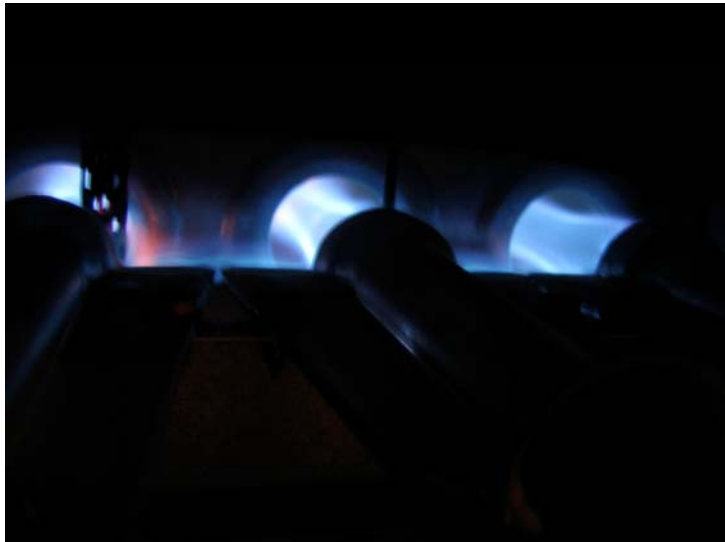
This is a relatively new heating system that should have years of useful life remaining. Regular maintenance will, of course, be necessary. The heating unit does not utilize a pilot light, thereby increasing its seasonal efficiency.

Based on information obtained from the furnace's data plate, the furnace is believed to be approximately 3 years old.

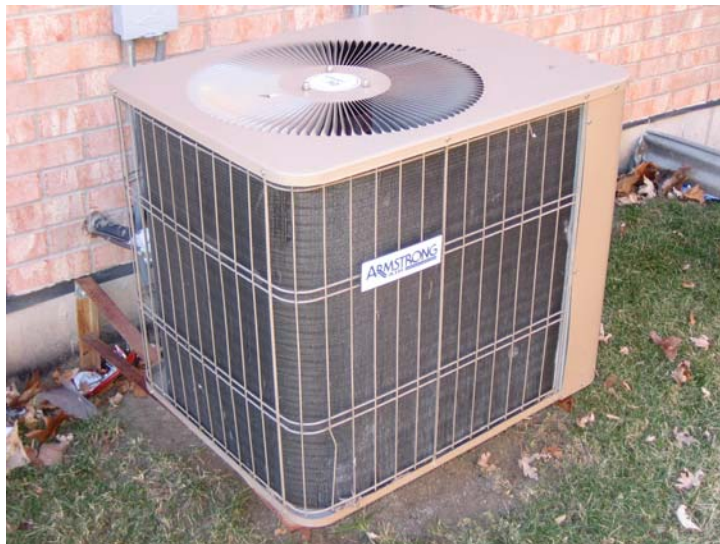
This is a relatively new cooling system that should have years of useful life remaining. Regular maintenance will, of course, be necessary.

Based on information obtained from the air conditioning unit's data plate, the air conditioning unit is believed to be approximately 3 years old.

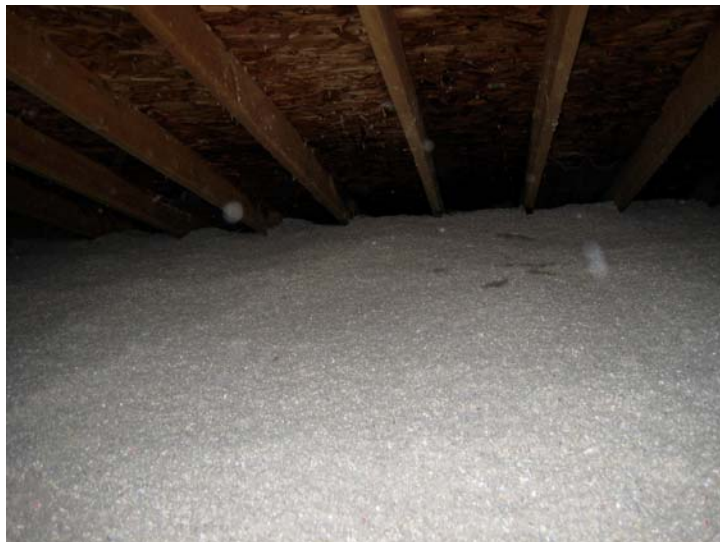
This is a well insulated home.

A certificate of insulation was observed in the house attic.
