Building Inspection Report

123 Any Street, Anytown, Illinois

Inspection Date:
February 16, 1997

Report Number:
17310

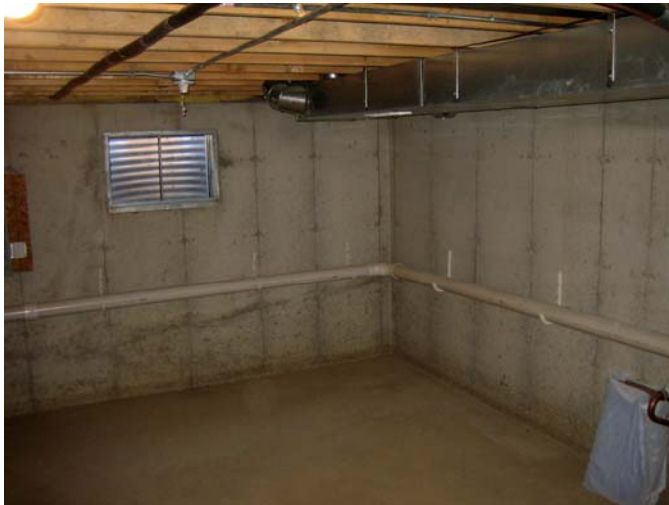
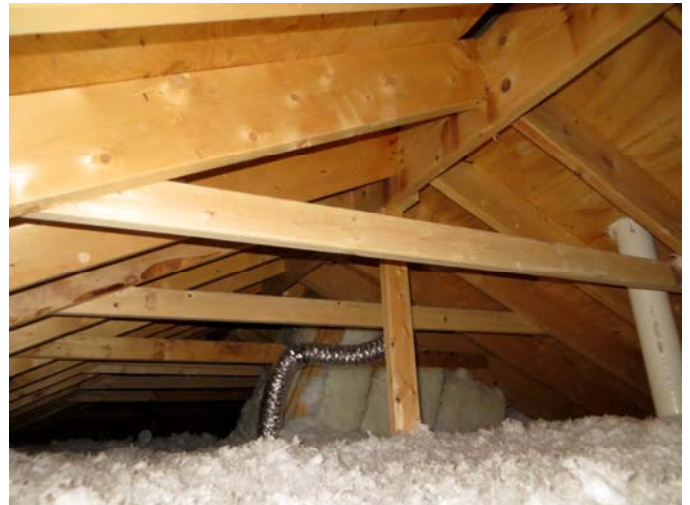
No major defects were observed in the accessible structural components of the house.

- **Repair:** The ends of the main support beam should be cemented into the "beam pockets" to reduce the risk of structural movement and damage.

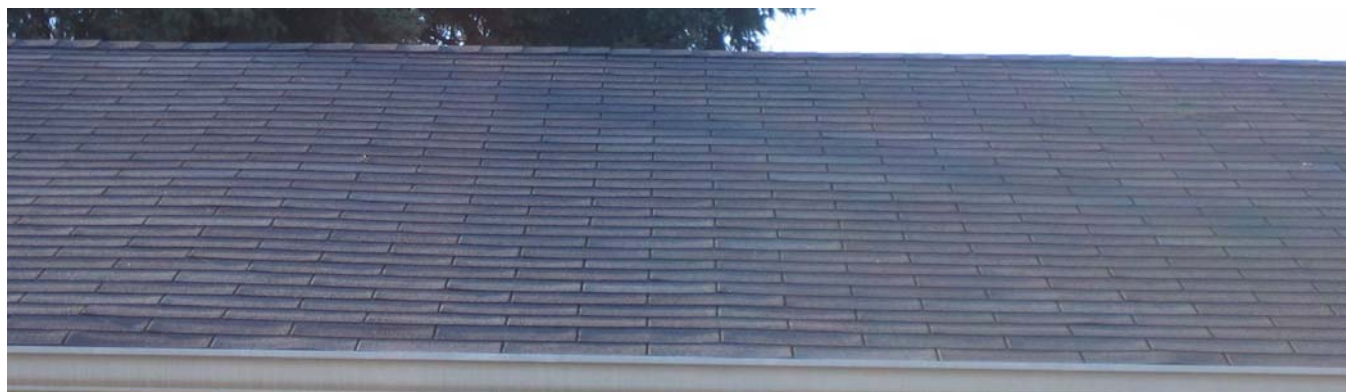
The roof coverings are considered to be in good condition.

A single layer of roofing materials exists.

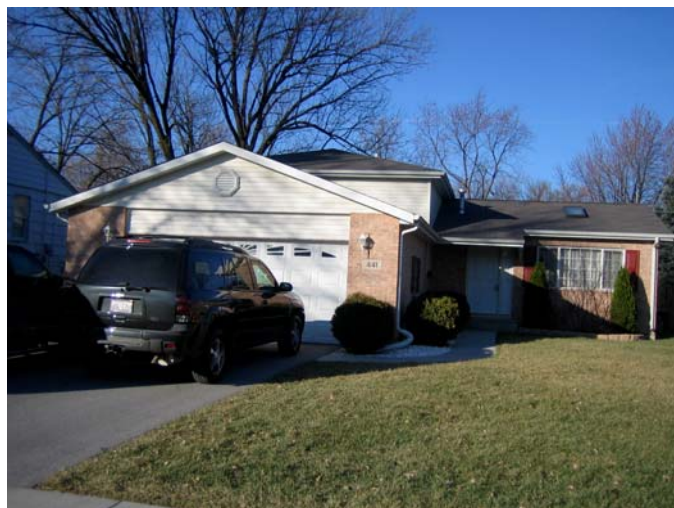
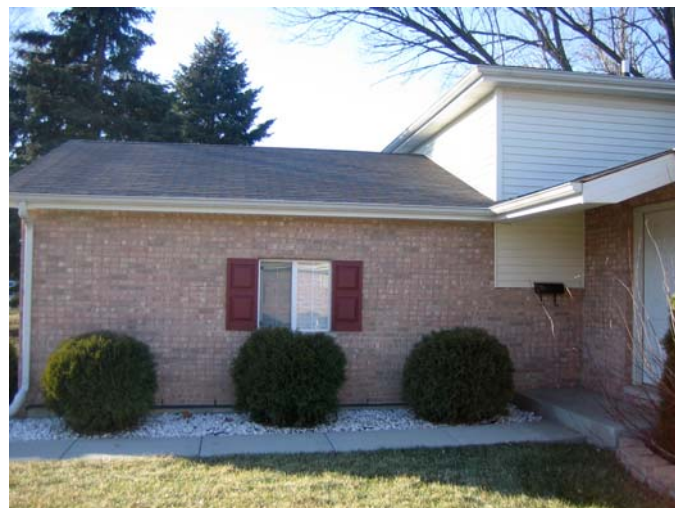
The exterior of the home is in generally good condition.

The application of a driveway sealant would offer protection from moisture and sunlight. This can help to prolong the driveway life.

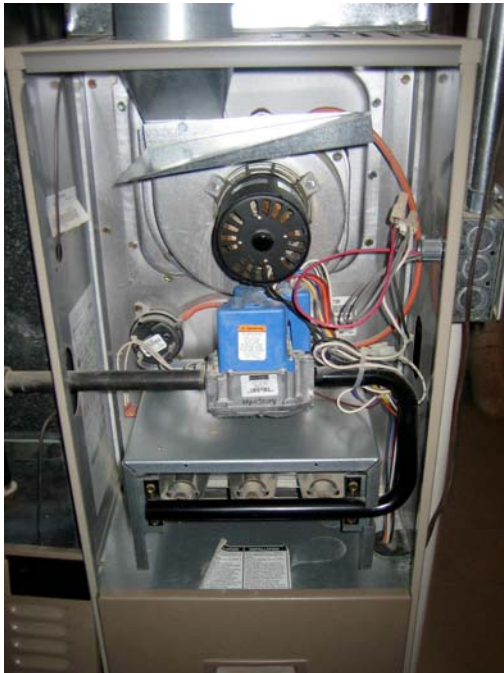
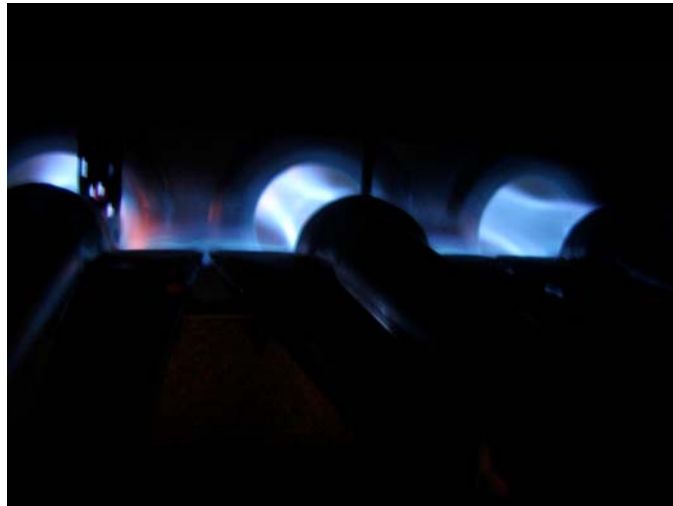
At 3 years old, the furnace is a relatively new unit that should have years of useful life remaining. Regular maintenance will, of course, be necessary. The heating unit does not utilize a pilot light, thereby increasing its seasonal efficiency.

The furnace filter is the disposable type and is located to the left of the furnace. The filter size is 16 x 25 x 1. When replacing the filter, the airflow direction arrow on the new filter should point toward the furnace.

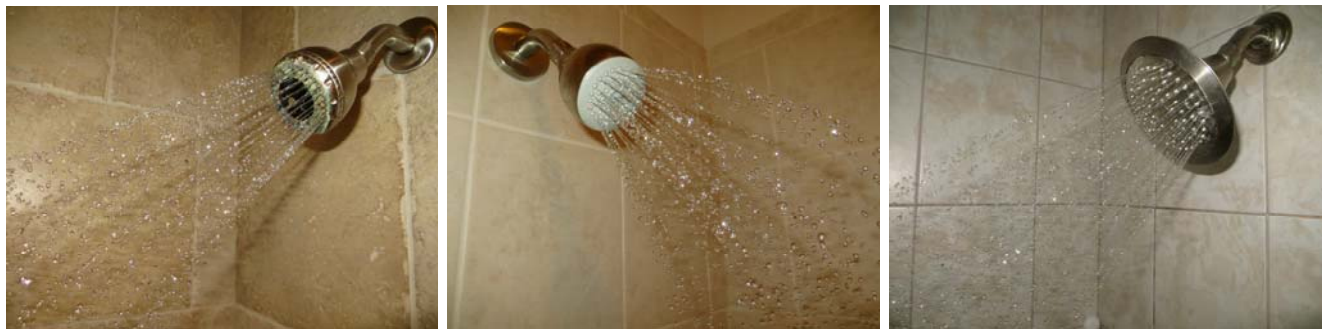
The water pressure supplied to the fixtures is considered to be reasonably good. A typical drop in flow was experienced when two fixtures were operated simultaneously.

The plumbing system requires some typical, minor improvements.

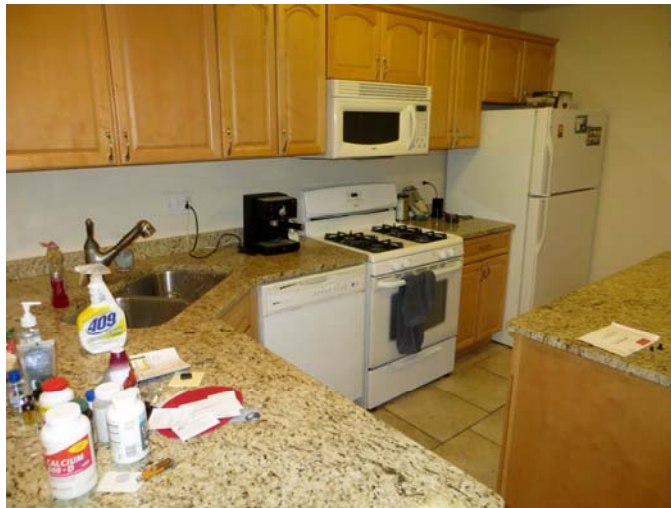
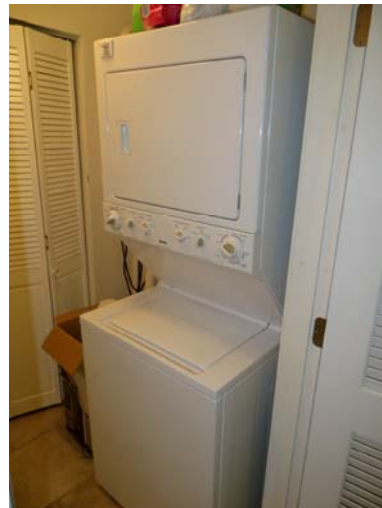
All appliances that were tested responded satisfactorily.
